**Flood Control Project Maintenance
Levee Inspections**
LMA District Cover Sheet
Spring 2019 Levee Inspection Results

Sutter Maintenance Yard East Levee Sutter Bypass

Spring 2019 Levee Inspection Results

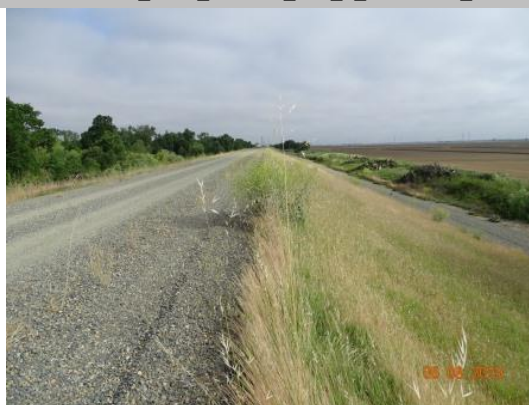
Photo 1 of 1 : SP_2019_ST0002_450_2_20190510_00084.jpg

LM Start	0.01	Rating **	U	Issue No.	2
LM End	21.78	Issue Type +	Ma	Location *	LS
Category	Earthen Levee			GPS Latitude/Longitude	
				Start	End
Item	Vegetation			39.151161 °	38.898028 °
				-121.832000 °	-121.617900 °
DWR ID	DWR_ST0002_01_s_2012_2				
Comment Code					
V1 : Control annual grass and weeds on the levee slopes and easements.					
Inspector Comment

View of the vegetation on the landside slope. Spring 2019.

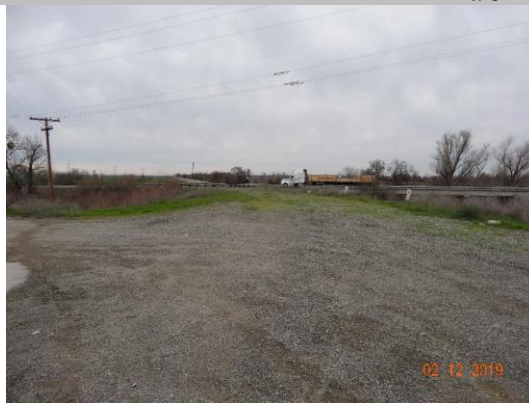
Photo 1 of 3 : UCIP_SP_2019_53669_78814.jpg

Comment Code					
Inspector Comment					
FS_ID:53669 DS_ID:16867 EP_NO: 768 Repair Type: Non-Urgent Crossing Status: Indicator Found UCIP Comments: 02/12/2019 Need to request maintenance and inspection records to confirm condition of line through levee. Gas line marker previously located on the WS slope has been damaged, recommend replacing. Structure description has been updated based on the permit review of 14802 (dsid 16867) and 768 (dsid 25575). USACE PI issue references Permit No. 768 for this crossing correct Permit No. should be 14802. (O. Magana - DWR UCIP)4/11/2017 Crossing appears to be in good condition. (DWR Sutter Yard-AFreitag)10/10/2016 Crossing appears to be in good condition.(DWR Sutter Yard - afreitag)4/18/2016 Crossing appears in good condition. No noticeable issues to report.5/7/2015 Crossing is in good condition. No noticeable issues to report.11/12/2014 Same as last inspection.5/13/2014 Same as last inspection.10/30/2103 Same as last inspection.5/22/2013 Same as last inspection. FIELD_STRUCT_DESC: 4-inch steel gas line through the levee, 30-inches below the crown. Carsonite marker located on the waterside (WS) shoulder and on road, 200 feet east of levee crossing (4-inch line authorized under Permit No. 14802, 1987 - Pacific Gas and Electric Company [PG&E]; 4-inch line replaces previous 3.5-inch line authorized under Permit No. 768, 1939 - PG&E). FS Date: 2/12/2019 3:01:00 PM

Overview of levee section looking towards HWY 20.

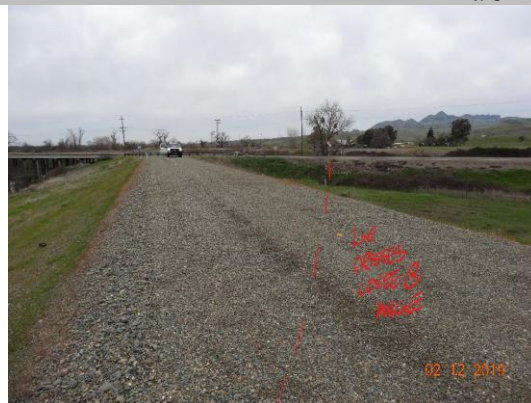
Photo 1 of 3 : UCIP_SP_2019_53671_78827.jpg

Comment Code						
Inspector Comment						
FS_ID:53671 DS_ID:16860 EP_NO: 4795 Repair Type: Non-Urgent Crossing Status: Indicator Found UCIP Comments: 02/12/2019 (O. Magana - DWR UCIP)01/10/2019 Permit records indicate marker signs were to be placed over the gasline in the bypass channel and in the levee section - confirm in the field. (O. Magana - DWR UCIP) 4/11/2017 Crossing appears to be in good condition. (DWR Sutter Yard- AFreitag)10/10/2016 Crosing appears to be in good condition.(DWR Sutter Yard - afreitag)4/18/2016 Crossing appears in good condition. No noticeable issues to report.5/7/2015 Crossing is in good condition. No noticeable issues to report.11/12/2014 Same as last inspection.5/13/2014 Same as last inspection.5/22/2013 Same as last inspection.10/30/2103 Same as last inspection. FIELD_STRUCT_DESC: 10-inch steel gas line through the levee, 4 feet below the crown. Pipe is 0.375 inches thick and soil proofed. Pressure gas line goes through the left bank, under the channel of Sutter Bypass, and right bank. (10-inch line authorized under Permit No. 4795, 1965 - Pacific Gas and Electric Company [PG&E]). [Additional Reference(s): DWR Levee Log, 2005]. FS Date: 2/12/2019 3:02:00 PM

LV crown: assumed gasline alignment through levee (line goes through levee at an angle)

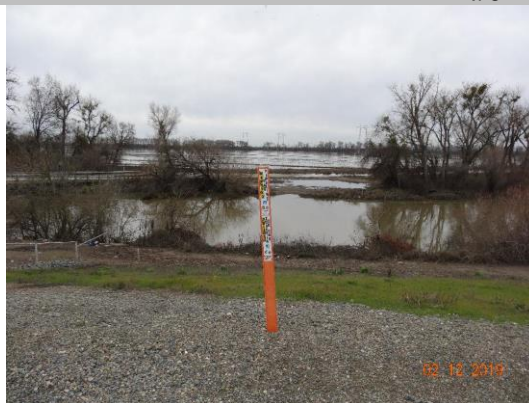
Photo 2 of 3 : UCIP_SP_2019_53675_78851.jpg

WS view: marker located on WS shoulder. Markers photographed in 2012 are no longer present.

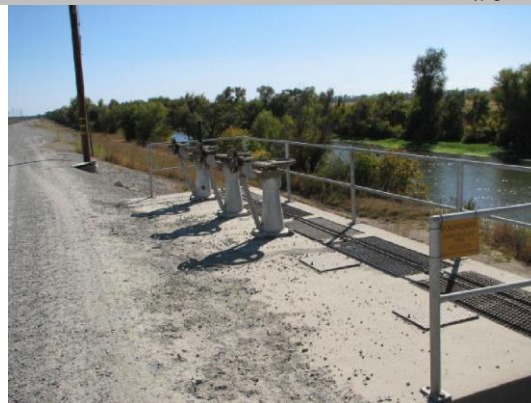
Photo 1 of 3 : UCIP_SP_2019_53898_65254.jpg

Slide gates on WS shoulder.

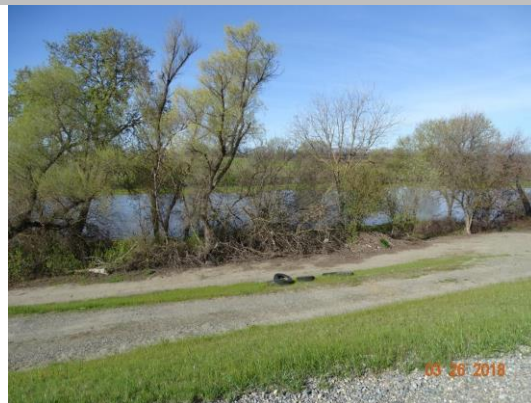
Photo 1 of 1 : SP_2019_ST0002_450_44_20190327_00010.jpg

View of the tires along the waterside slope and toe.

LM Start	12.75	Rating **	M	Issue No.	44
LM End	12.75	Issue Type +	Ma	Location *	WS
Category	Earthen Levee			GPS Latitude/Longitude	
				Start	End
Item	Encroachments			38.998698 °	38.998698 °
				-121.718062 °	-121.718062 °
DWR ID	DWR_ST0002_01_s_2018_44				
Comment Code					
MA : Material					
Inspector Comment					
Remove the tires from the waterside slope and toe.

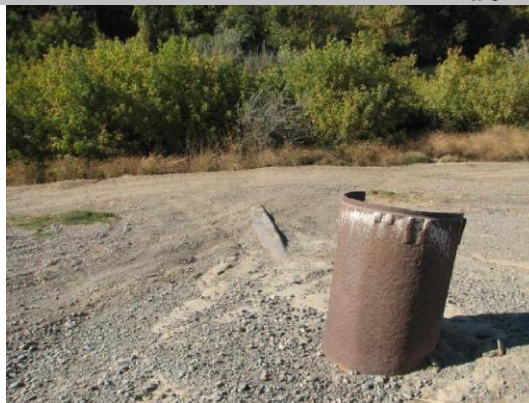
Photo 1 of 3 : UCIP_SP_2019_53937_65314.jpg

Pipe on WS slope exposed and crushed below 30-inch steel riser.

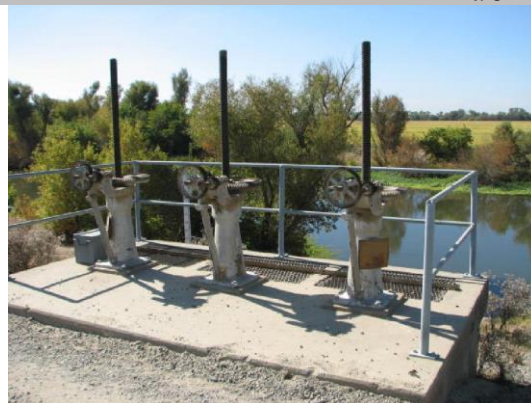
Photo 2 of 3 : UCIP_SP_2019_53911_65325.jpg

Slide gates on WS shoulder.
